To: Heidi Sickler (Kinder Morgan Energy Partners)

From: Nick Ricono (TRC)

Date: May 23, 2006

Subject: **Results of Sensitive Species Surveys for the Washout Repair Project on Line Section 111 in the San Gorgonio River, Riverside County, California**

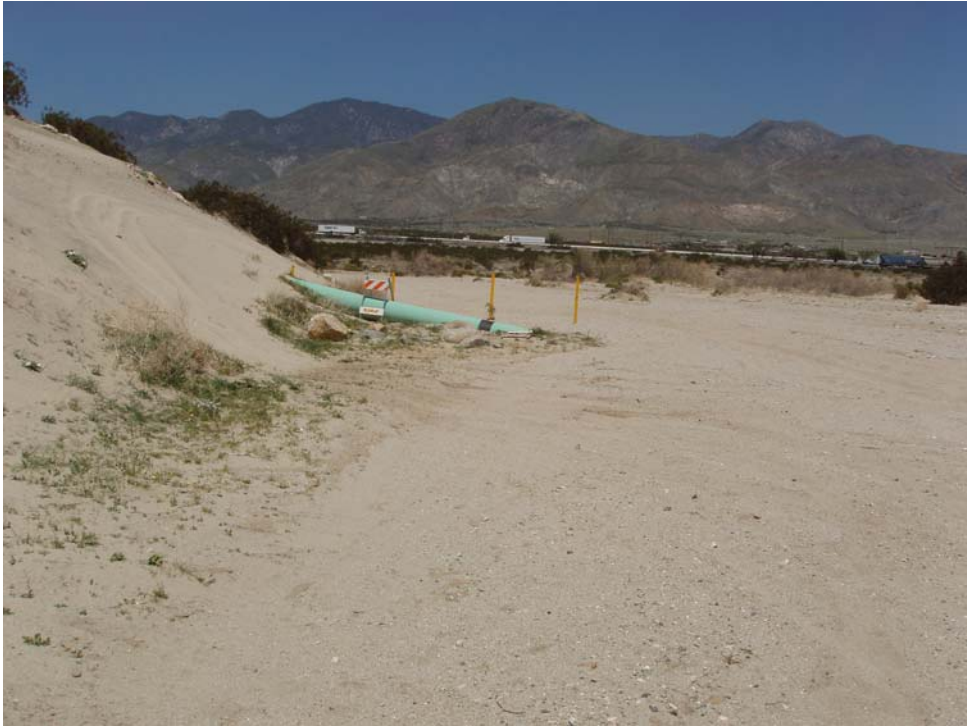
Area 1 occurs along the western bank of the San Gorgonio River on the eastern slope of a large sand dune that washed away, leaving approximately 30 feet of pipeline exposed. SFPP plans to reconstruct the base of the sand dune using the FCR for protection against future storm events. The FCR structure will be approximately 3-feet-high and 125-feet-long and will be keyed into the hillside 10 feet along its northern edge for a total impact area of 0.07 acre. The area behind the FCR will be filled with 247 cubic yards of sand collected from the base of the stream channel adjacent to the FCR over an area of 0.14 acre at a depth of 1 foot. The backfilled area will be covered by a synthetic material in order to keep the sand in place. The impacts related to the construction of the FCR will be permanent. Impacts to the stream channel during excavation of sand will be temporary as subsequent storm events will re-contour the channel naturally.

Photo 1 - Area 1 washout facing north toward Interstate 10.

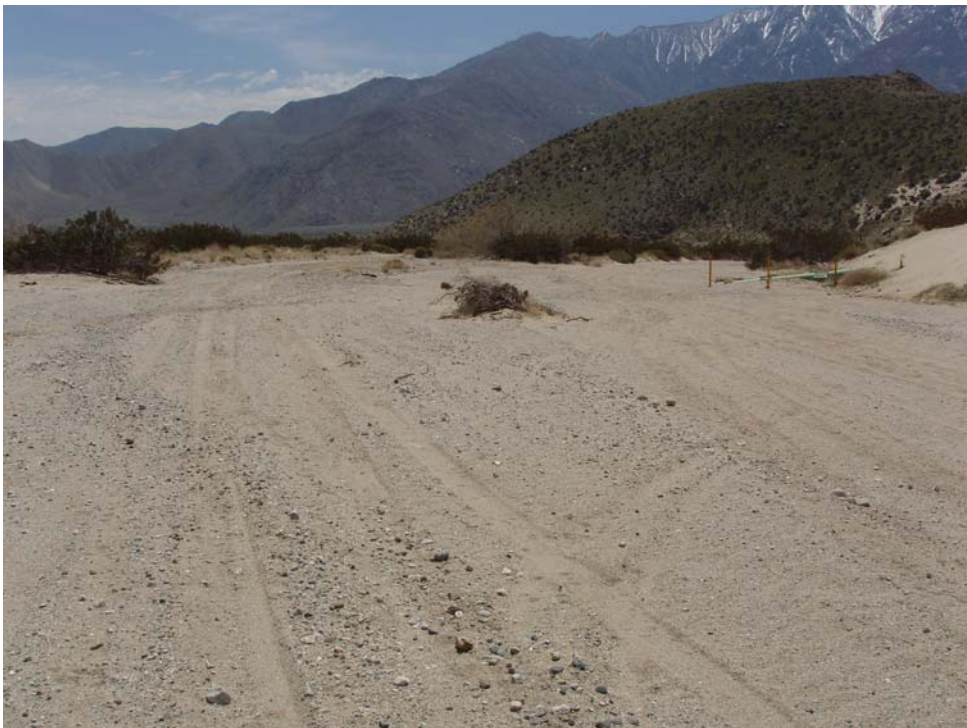
Photo 2 - Area 1 facing south showing washout location, proposed access route, staging and construction areas.

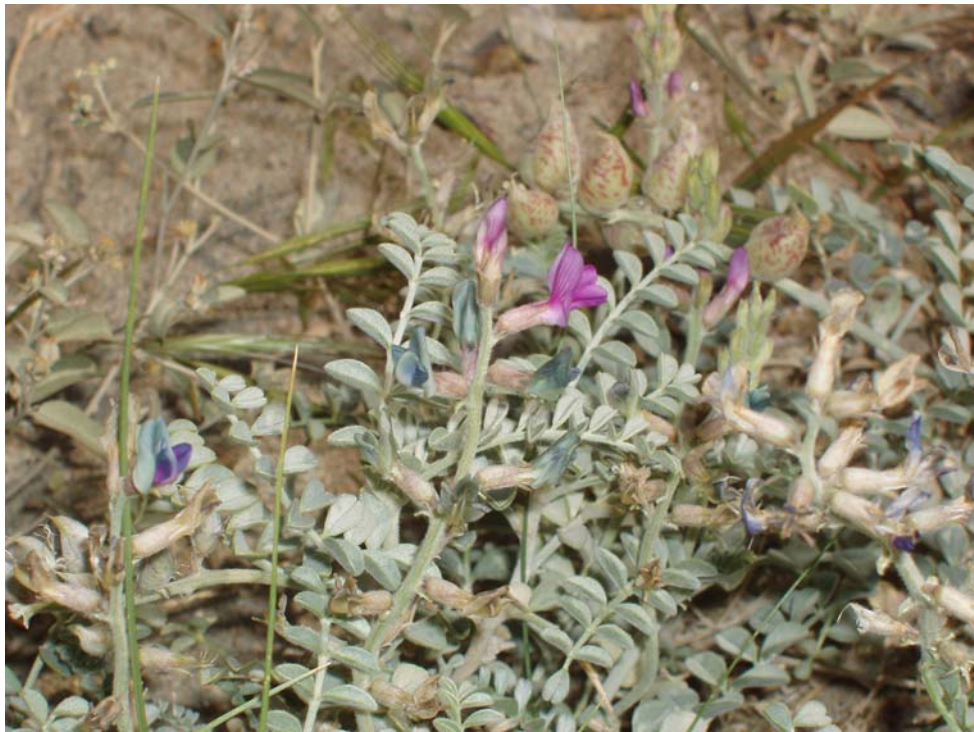
Photo 4 – Coachella Valley milk-vetch from the dune above the Area 1 washout.
Photograph taken during 4/21/06 survey.

Based on the survey results, CVMV is present in Area 1 approximately 150 feet west of the washout location. The CVMV population is located on top of the dune and will, therefore, be easily avoided during access, staging, and construction in the project area. A potential DT burrow was observed in Area 2 so DT protection measures should be instituted in order to avoid take of the species. No CVFTL were identified in the project area but the highly mobile species may enter the project area at any time. Therefore, the following mitigation measures will be instituted to insure the protection of the CVMV, CVFTL, DT, and other sensitive species that may occur in the project area.

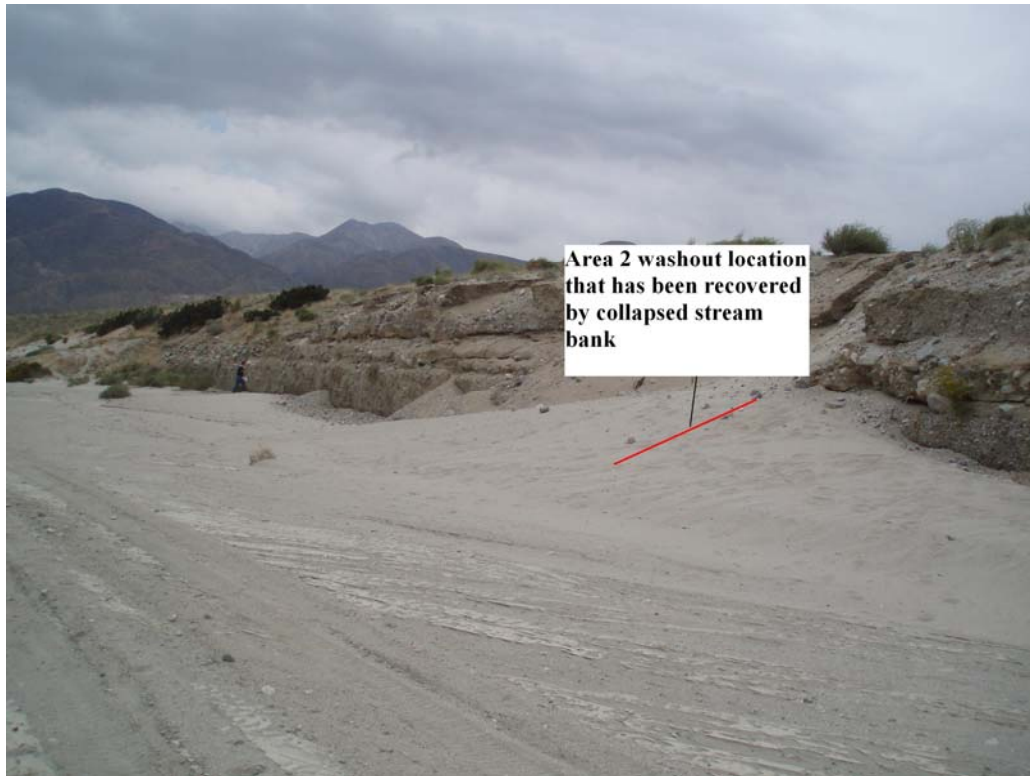
Area 2 occurs along the eastern bank of the San Gorgonio River at the base of a steeply sloping ledge that rises approximately 12 feet high from the base of the stream channel. Erosion during the flood events cut away the base of the hill leaving approximately 10 feet of pipeline exposed. Subsequently, earth from the ledge slumped back into the void re-covering the pipeline. SFPP plans to reconstruct the base of the hill using the FCR for protection against future storm events. The FCR structure will be approximately 4-feet-high and 180-feet-long for a total impact area of 0.11 acre. The area behind the FCR will be filled with 20 cubic yards of material collected from the top of the hill. The impacts related to the construction of the FCR will be permanent.

Photo 5 - Area 2 washout facing north showing the location within the eastern stream bank. The bank has collapsed re-covering the pipeline washout.

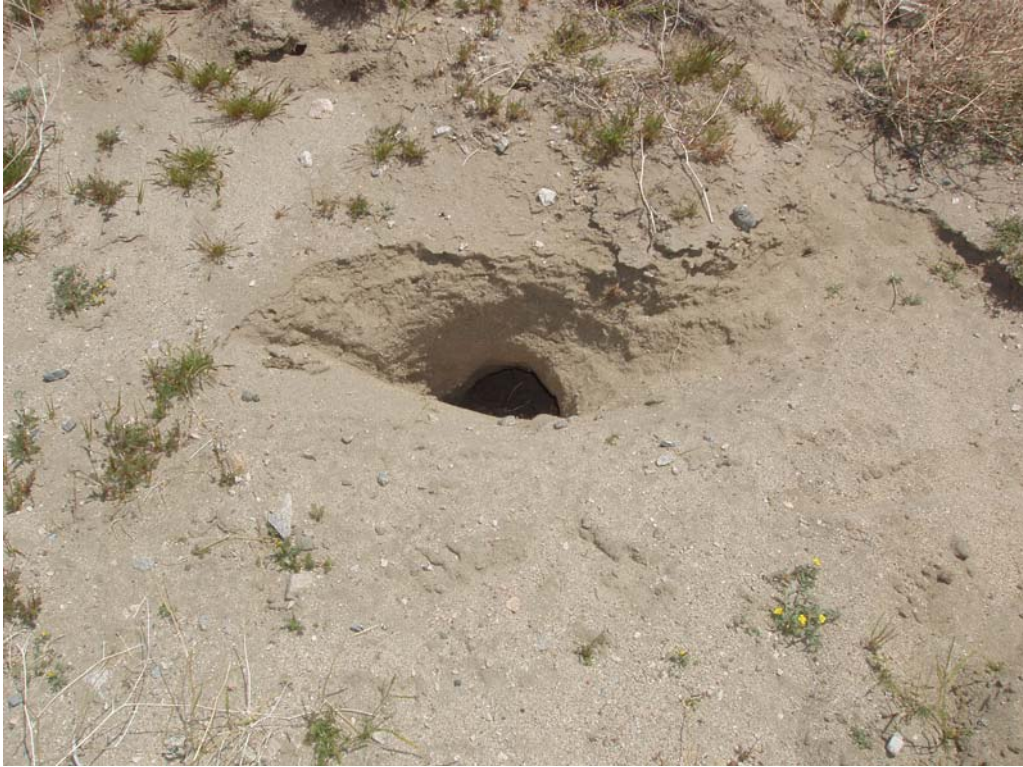
During surveys east of Area 2, a potential DT burrow (Class 4-deteriorated condition, possibly tortoise) was observed approximately 120 feet north of the washout location, approximately 30 feet east of the ledge that makes up the eastern stream bank, and approximately 90 feet west of the railroad tracks (Figure 1, Attachment A). The Class 4 burrow had the shape of a DT burrow but was steep (approximately 5 degree angle) at the entrance (See photo documentation in Attachment B). The burrow traveled approximately 14 inches deep before turning sharply to the left and continuing out of sight. No tortoise sign was observed in or around the burrow. Canine scat was present at the mouth of the burrow and the sand above the mouth of the burrow had caved in. The burrow could potentially be the results of canine excavation of a rodent burrow coupled with erosion leading to the distinct half-moon shape of a standard DT burrow. No further DT sign was observed in Area 2.

Photo 7 – Potential desert tortoise burrow found 120 feet north of the Area 2 washout, 30 feet east of the eastern stream bank of the San Geronio River and 90 feet west of the railroad tracks.

- 3) Area 2 shall be surveyed by a USFWS authorized biologist for DT sign within 48 hours of the onset of project activities. Should a DT burrow be found in the project area, the biologist will insure that the burrow is un-occupied and flagged for avoidance. Should an occupied DT burrow be found in the project area, further consultation with the USFWS will be required to determine potential impact to the species.
